**Overview** The visual inspection of synthetic ropes before use is critical in most industrial applications. The residual strength of a rope, the prime indicator of its useful and safe remaining working life, must be assessed before committing the rope to continued use. With high-performance synthetics like HMPE replacing steel-wire ropes in many applications, the need for a method to determine the state of a rope is more critical than ever before. The problem is that there is no common, standardized language or reference scale to describe the state of a rope. To date, judgment on the state of the rope has required a synthetic rope expert to complete an inspection on-site. The alternative is removing the rope from service and testing the rope to destruction in order to evaluate residual strength.

## The Abrasion Comparator

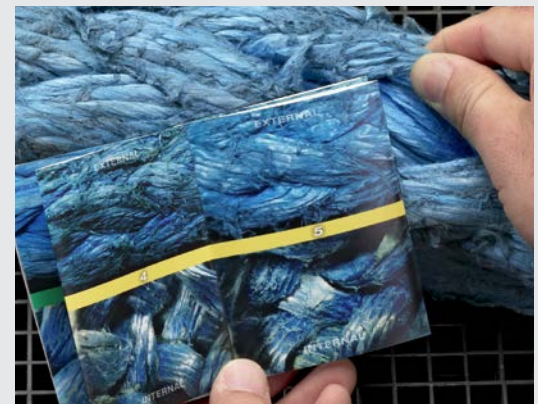
*The comparator is an easy reference that can be used in the field to help assess the state of a rope. Small and easily held in the hand while performing an inspection, it helps establish a guideline and a common language when discussing the state of a rope.*

The Abrasion Comparator shows a 12-strand HMPE rope—*AmSteel® Blue*—in a range of abrasion states from new rope to rope ready for retirement. The images represent a scale numbered from 1 through 7 that ranges from minimal strength loss (steps 1 and 2), significant strength loss (steps 3 through 5), to severe strength loss (steps 6 and 7). Each is further tagged with an action—for ropes with significant strength loss, consult Samson; for severe strength loss, retire the rope. Images are provided for both external abrasion and internal abrasion. When consulting your Samson dealer or representative you now have a ready reference to accurately describe the state of the rope in question.

The comparator is an easy reference that can be used in the field to help assess the state of a rope. Small and easily held in the hand while performing an inspection, it helps establish a guideline and a common language when discussing the state of a rope. It is printed on extremely durable synthetic paper that is resistant to tearing and comes packaged in a vinyl sleeve to make it 'pocket friendly.'

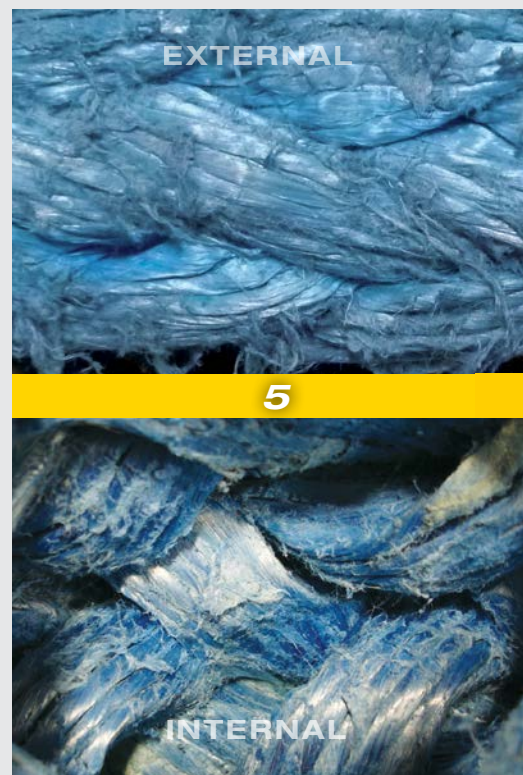
*Abrasion occurs both externally, along the surface of the rope and internally, inside the structure of the rope. It is important to evaluate both forms to accurately assess the condition of the rope.*

*SHOWN AT ACTUAL SIZE: The detailed photos make comparison quick and accurate.*
